热线问题:

使用 S7-400 CPU 调用 FB286/FB287 修改 G120 变频器参数报错, 错误代码 80B5。更换 ET200S CPU IM151-8 后同样程序一切正常, 可以排除变频器问题。

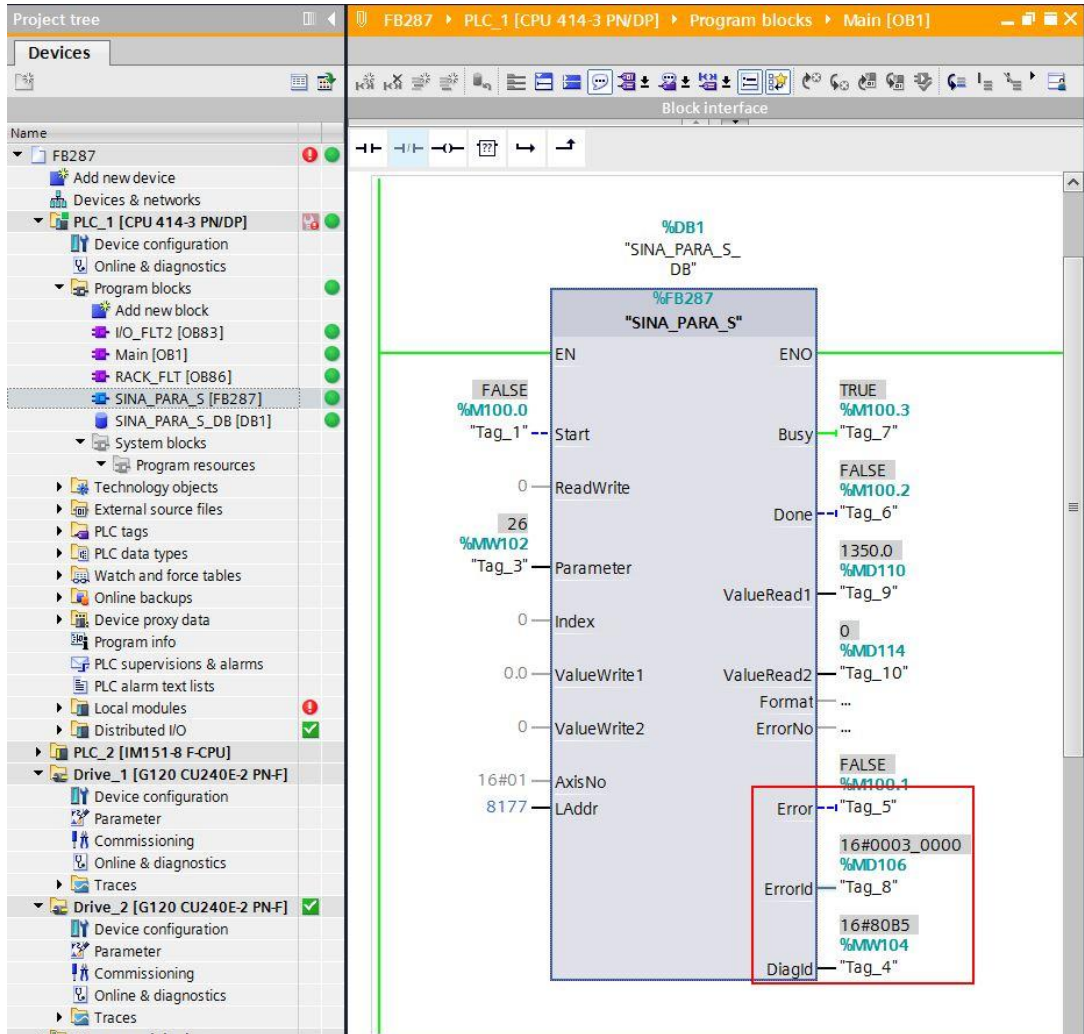
FB286/287 是 TIA Portal 中用于 SINAMICS S/G 变频器库 DriveLib 中的功能块, 用于非周期读取变频器参数。根据客户描述进行测试, 使用 CPU414-3PN/DP 通过 FB287 读取 G120 的 26 参数直流母线电压, 功能块报错 16#80B5。该功能块后台调用的读写数据记录指令 WRREC/SFB53 和 RDREC/SFB52, 查询错误代码含义是“从站未准备好”。

图 1 CPU414-3PN/DP 使用 FB287 报错

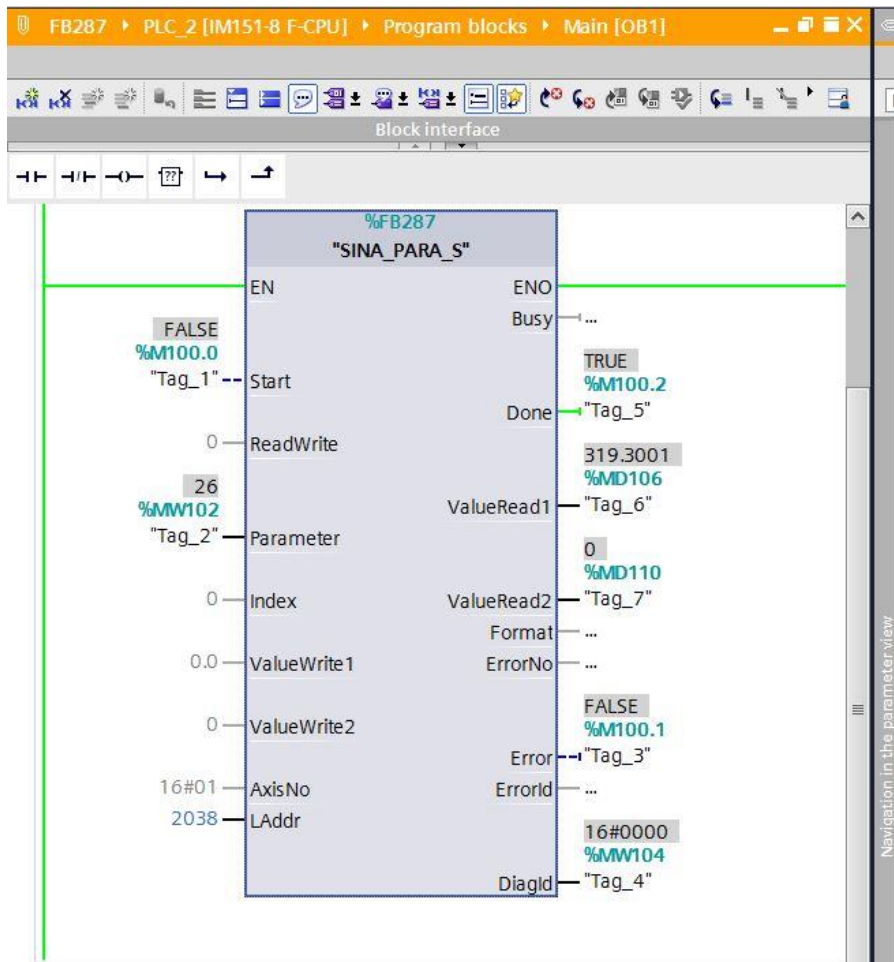
同样程序，将 CPU 更换为 IM151-8PN/DP 后，参数可以正常读取。

图 2 IM151-8PN/DP 使用 FB287 正常

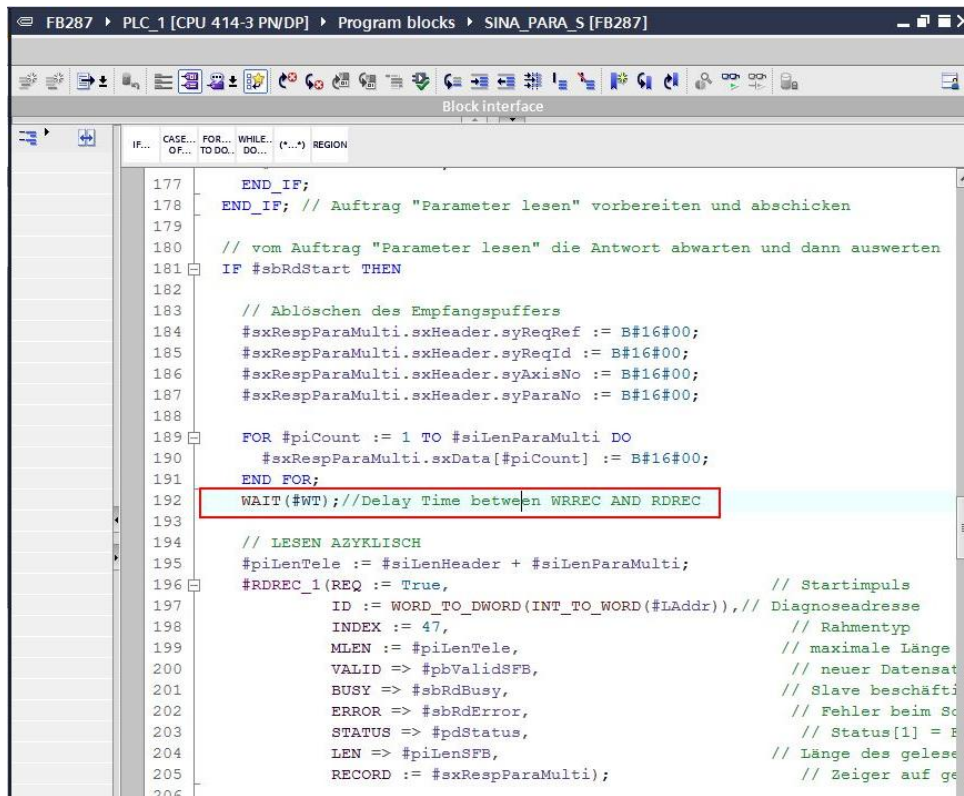
图 3 修改 FB287

1、简单查看了一下 FB287 程序，在写参数号和读取参数值语句间增加了一段 WAIT 语句，故意将写和读的间隔拉长，再使用 CPU414-3PN/DP 进行测试，可以正常读取参数值。

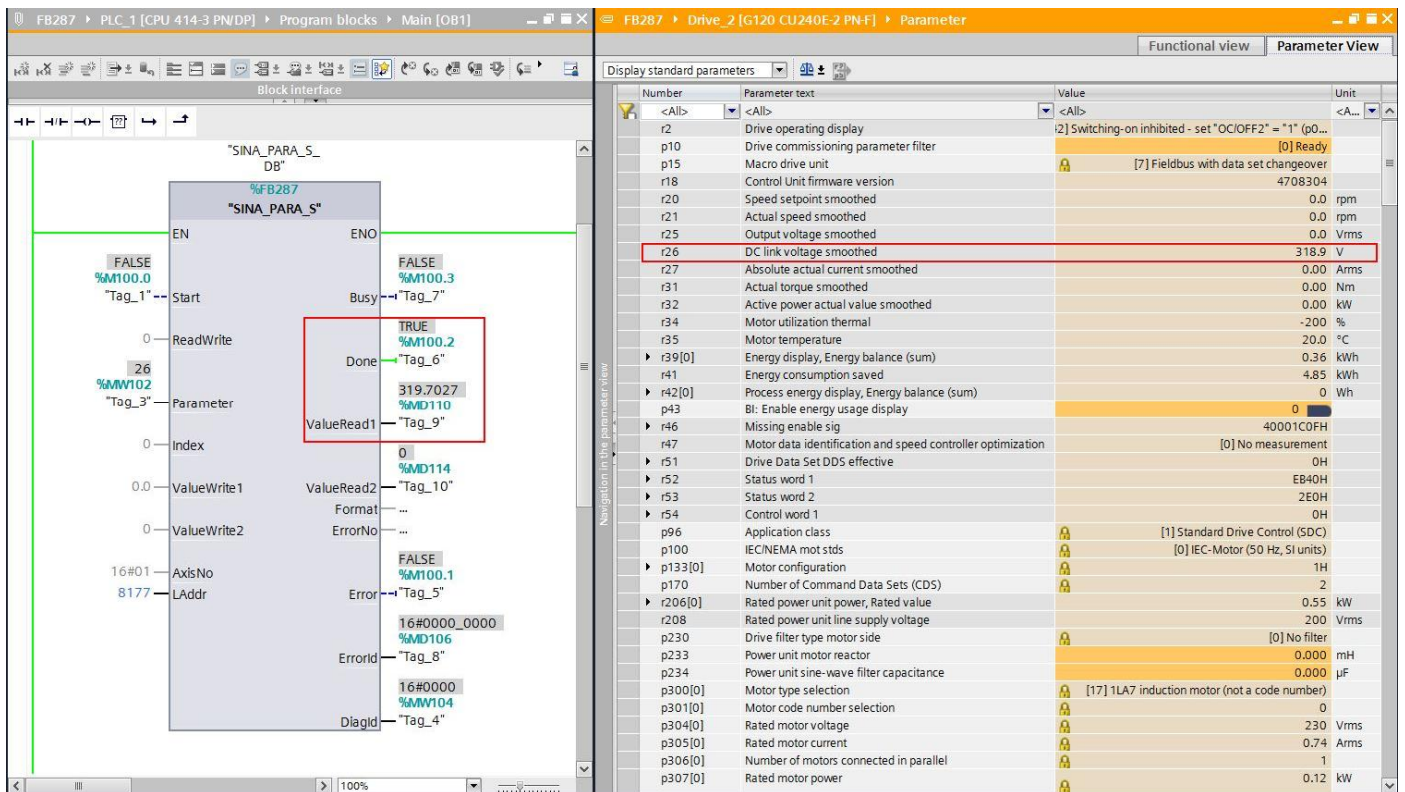
图 3 修改 FB287 后 CPU414-3PN/DP 可以读取参数值
