项目现场一：

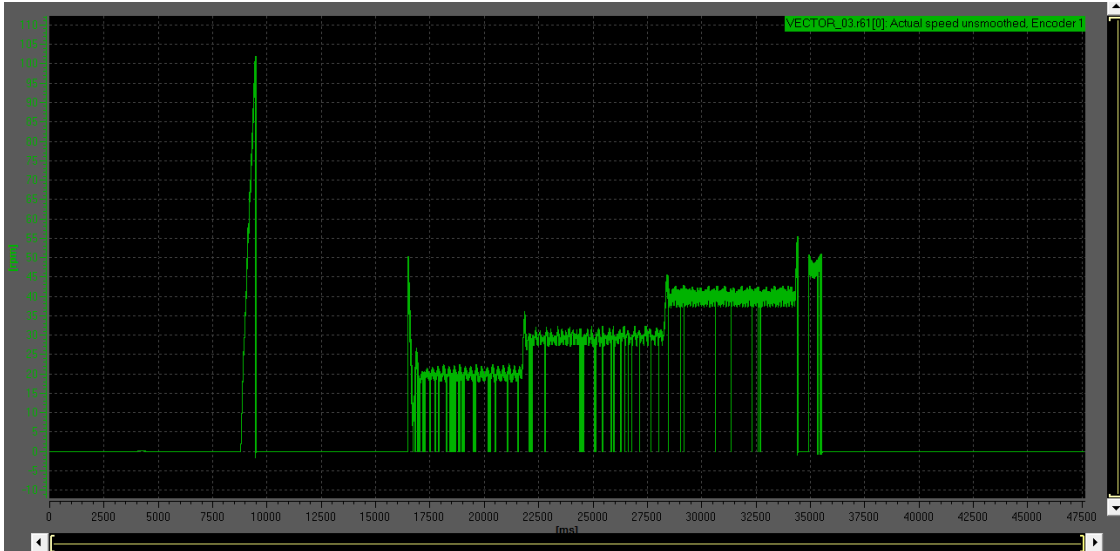
**现象：**编码器信号很多毛刺，转速超过 100rpm 后根本就监控不到信号。

**问题分析与处理：**检查现场发现，电机动力电缆的屏蔽层两端没有接地，按照规范接好后问题解决。

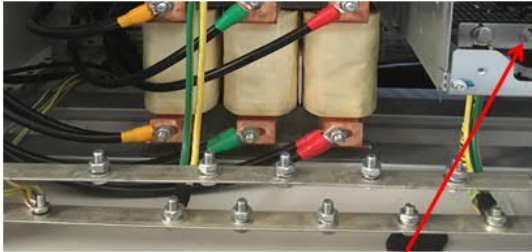
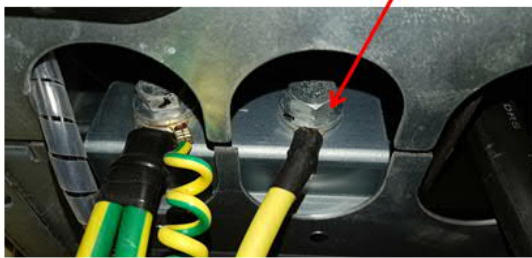
变频器逆变侧动力电缆屏蔽层的接地处理。

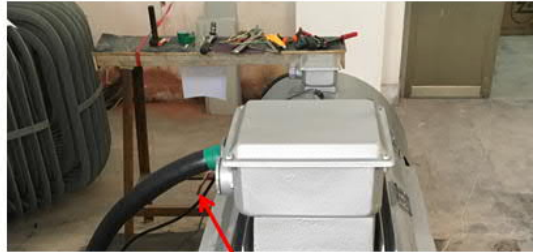
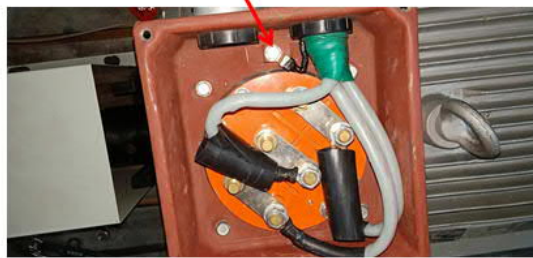
电机侧动力电缆屏蔽层的接地处理。
